# RICS **Building Survey**...

1 Example Street  
Example Town  
Example County  
EX1 8MP

11 October 2019

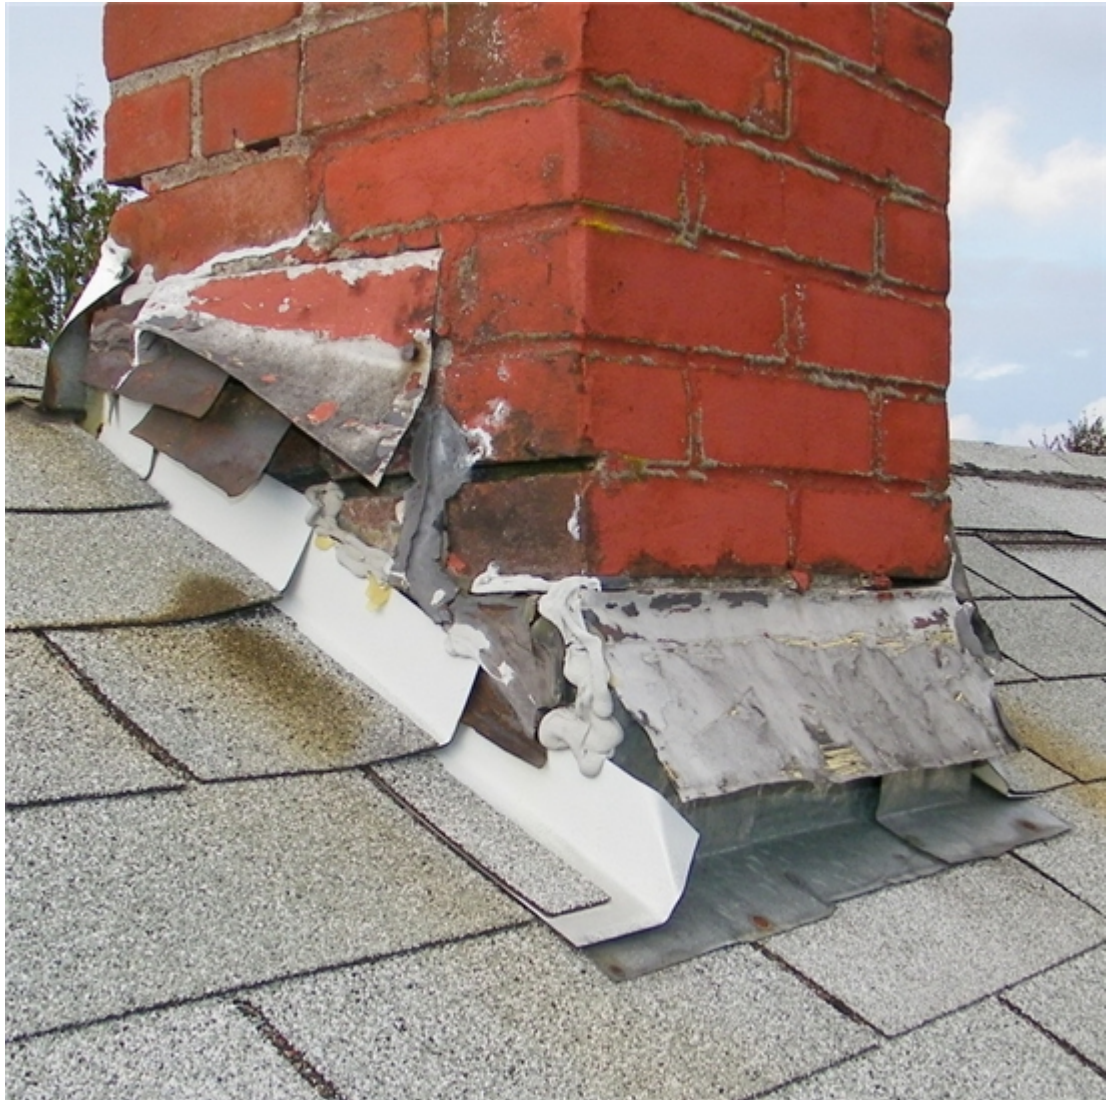
Poor flashing to the rear stack

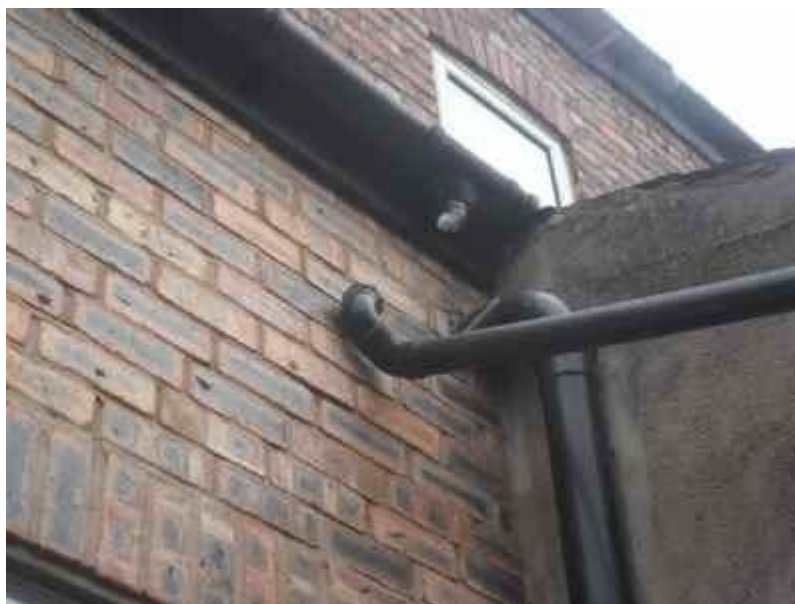
Rainwater down pipes were noted to discharge directly onto the ground adjacent to the front bay, a gully, if it exists, is blocked by vegetation and debris. Additional below ground drainage is essential to reduce the risk of movement to walls. Please see section G6.

Loose downpipe

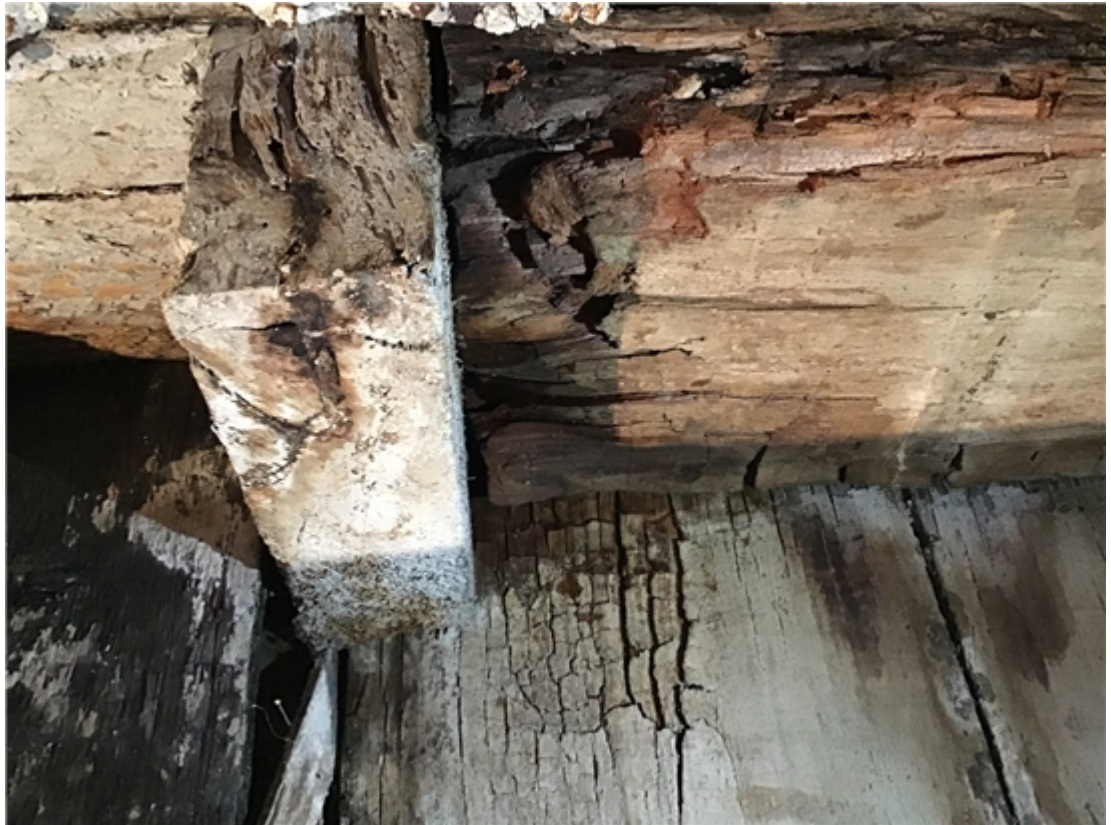
Around the chimney breast in the lounge there was some isolated evidence of damage caused by historic wood rot. This was noted to be relatively dry during my inspection, and it is possible that the rot occurred many years ago. The damage has not undermined the structure. With the absence of higher damp levels it is unlikely that further significant deterioration will occur. However i would recommend a precautionary treatment of timbers in this area with a dual purpose fungicide and insecticide.

Isolated rot around chimney breast

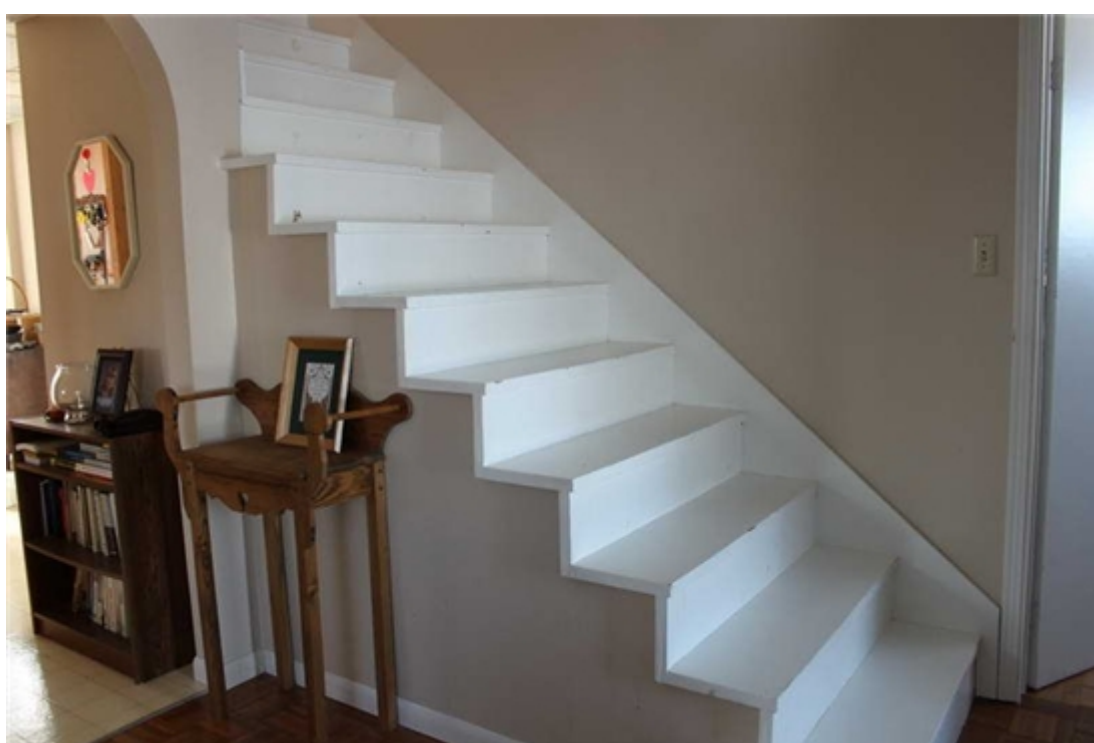
The staircase balustrading to the stairs has been removed. This may represent a hazard and early reinstatement is recommended as soon as possible. Please see section J3.

## Unsafe Stairs

Estimated cost in providing balustrade £300

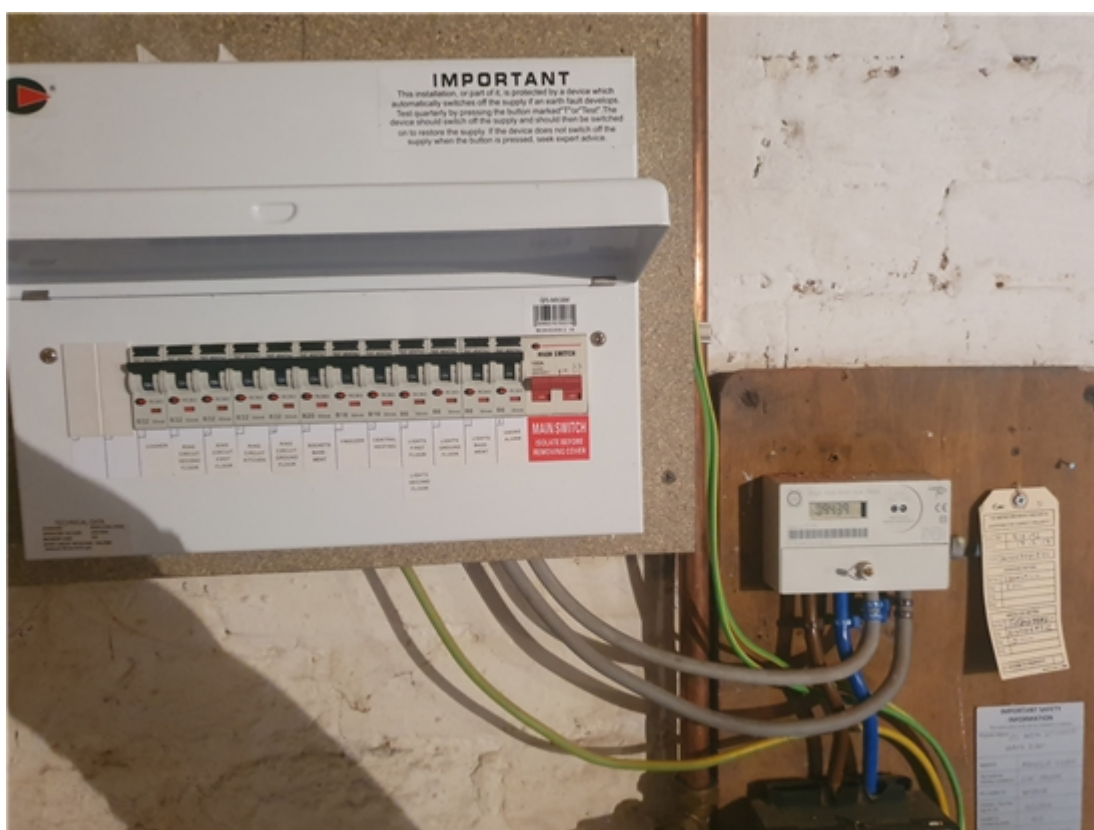
G1: Modern metal consumer unit

The observed wiring and fittings are modern. The consumer unit (fuse box) is a modern metal design, the circuits appear RCBO protected.

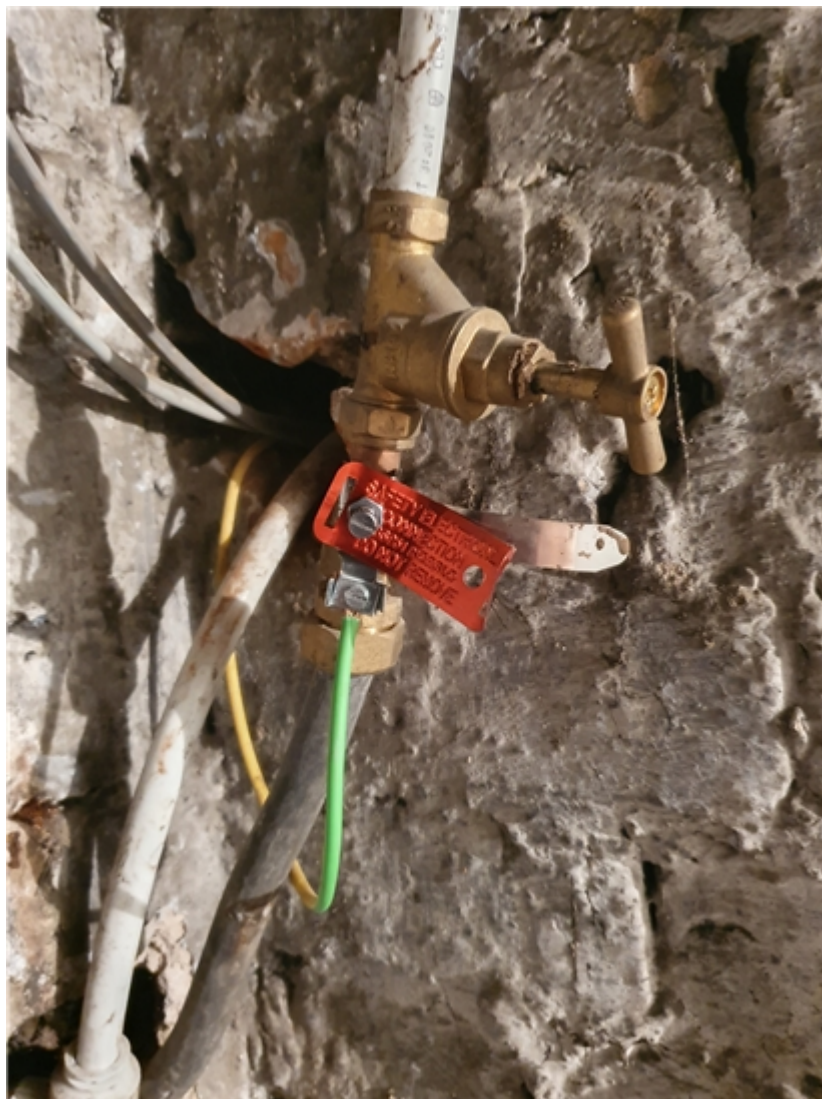
G3: Lead water supply pipe.

The water supply pipe which supplies the property with water from the outside main was noted to be lead with all remaining pipework seen within the property plastic. 3

Lead water pipes were commonly used to supply water to dwellings before the 1970's however there are now safety concerns relating to the way lead can build up in the body. Those at particular risk are infants and children because lead can have an adverse impact on mental development. Lead may also be a factor in behavioural problems. It is recommended that human exposure to lead is kept to a minimum. Therefore the remaining lead pipework supplying the property should be replaced for health reasons. See Section J3.

You are advised to instruct a plumber experienced in lead water supply replacement to provide a quotation for replacing lead pipework, complete with stop tap, drain tap, ducting and insulation fitted in accordance with the Water Fittings Regulations.
