RICS **HomeBuyer** Report...

1 Example Street
Example Town
Example County
EX1 8MP

10 October 2019

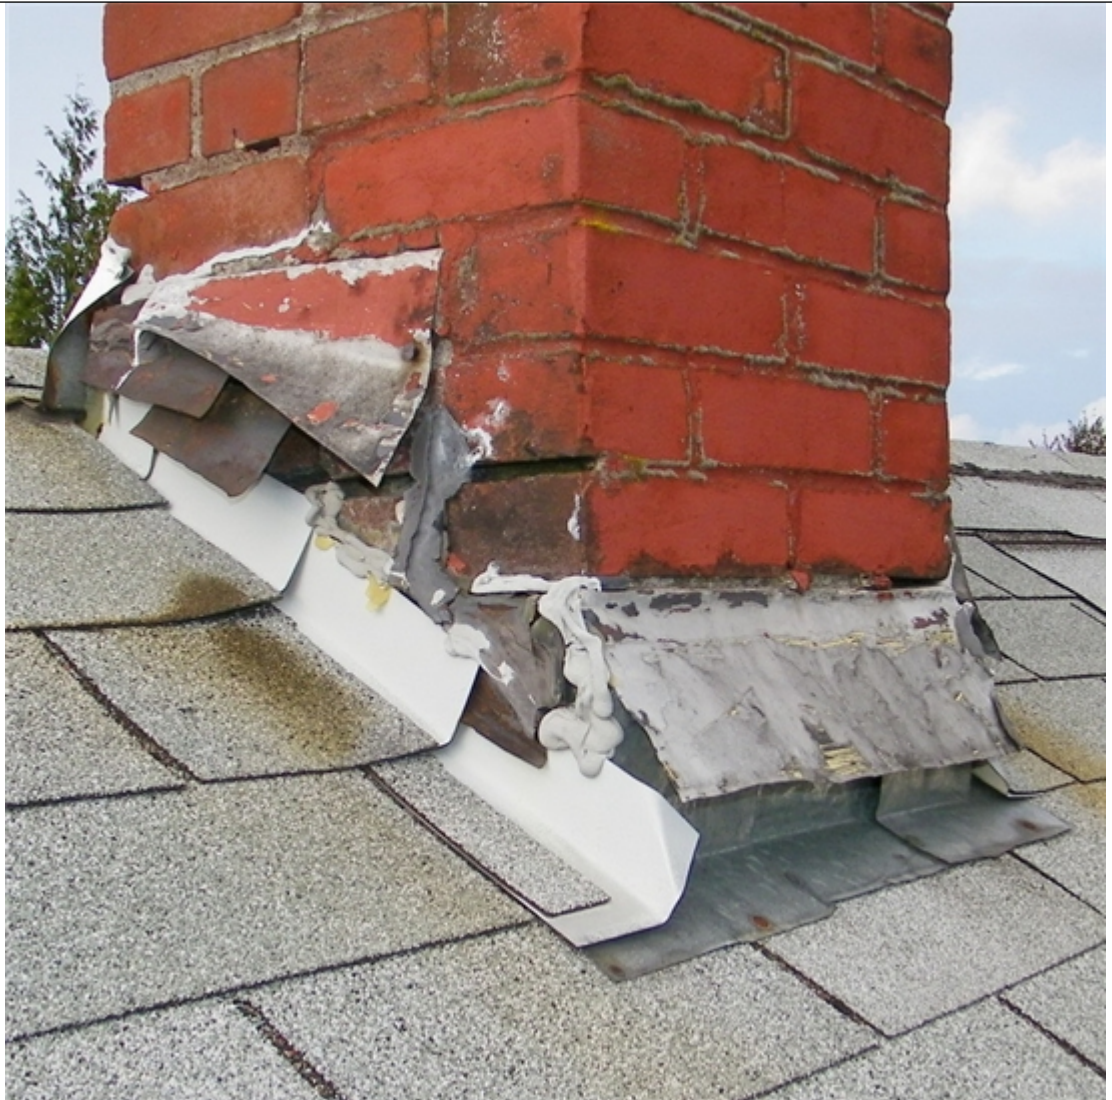
Lead flashing provides a degree of weather proofing to the chimney stacks. However this flashing was noted to be low, loose and missing on both stacks, it is not correctly bedded to mortar joints. Parts of the render and masonry are in poor condition. **Please see photo 2 at the end of this report.**

Dampness was noted internally to chimney breasts within the bedrooms indicating that rainwater may be penetrating around the chimney stacks.

You should instruct a roofing contractor to provide a report and quotation for the works required to the flashing. Scaffolding will be needed to gain access for these repairs and the costs may be high.

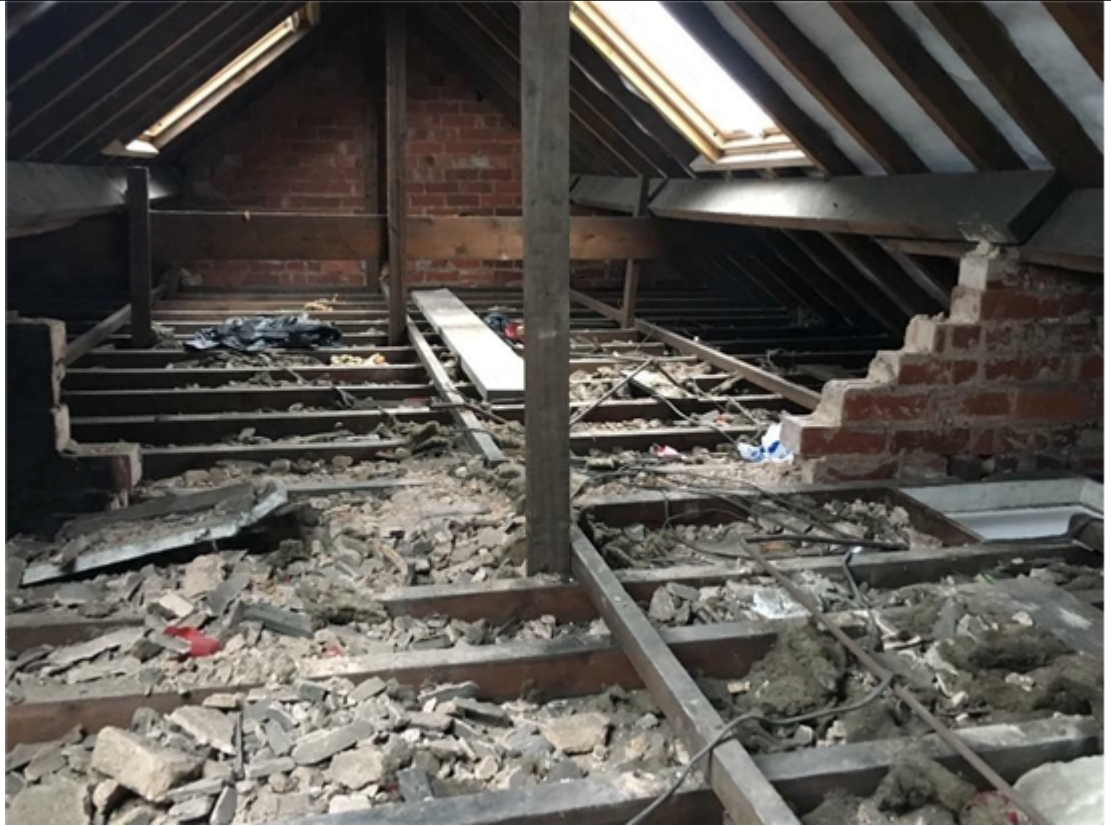
The party wall to the adjoining left hand side semi is incomplete. Easy access is possible into the property from next door's loft. This should be closed for improved security and fire safety, in co-operation with adjoining owners. See Section J1. **Please see photo 3 at the end of this report.**

You are advised to Instruct a building contractor to provide a report and quotation to close party walls in line with statutory regulations.
