# Expert Witness Report

## AND SCOTT SCHEDULE OF PROPOSED REINSTATEMENT WORKS

**1 Example Street, Example Town**

**Inspection Date: 14<sup>th</sup> Dec 2021**

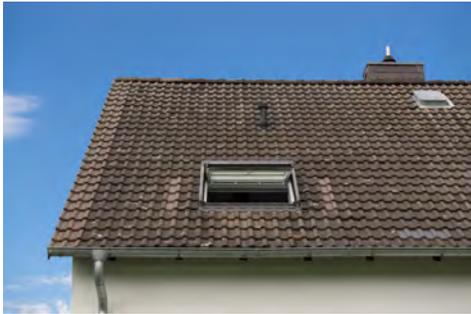
These tiles are now quite old, they do show signs of some deterioration, a number of tiles have already been replaced. These tiles are normally marketed with a life expectancy of around 50 years. Their age would normally be suggesting they would be approaching the end of their useful life. It was noted that some of the neighboring houses, including number 30 xxxx had already had their roofs recovered.

The roof pitches are quite shallow by design, these were measured at approximately 20 degrees, the low pitch will increase the risk of driving rain and snow entering beneath especially during high winds. This makes the role of the underlay all the more important; this acts as a secondary defense against any penetrating water which will occasionally and inevitably occur. It is designed to catch this water and channel it down towards the eaves and guttering away from the dwelling.

Front Roof Pitch

Unfortunately it is not possible effectively to provide a new underlay without also lifting all of the concrete tiles. Due to the age of these tiles new tiles should be provided at the same time.

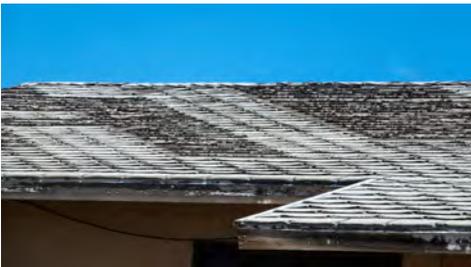
Rear Roof Pitch

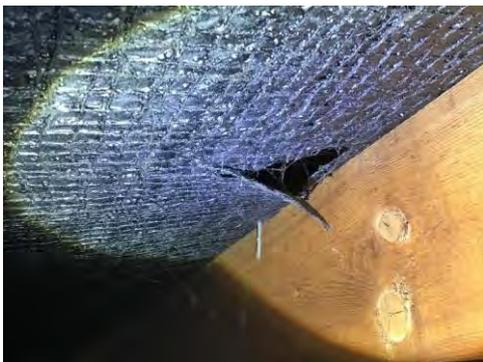
A large part of the issue with this roof appears to lie with the condition of the underlay as opposed to the tiles themselves. It is an old bitumen based underlay, very brittle and torn in a number of places. The tears to this underlay above the bathroom appear to be at least the partial cause of the leaks to this room, and I suspect that the various past leaks reported, and staining noted to other ceilings were caused by tears to this underlay.

Yes, the bitumen underlay could contain asbestos.

Brittle, torn bitumen underlay

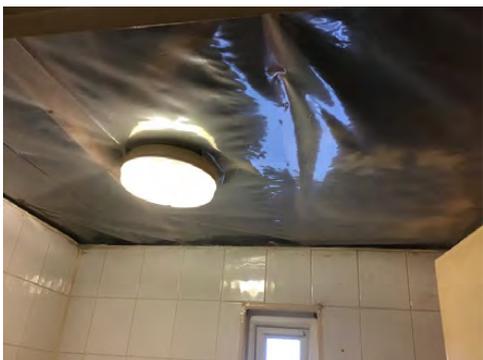
Bathroom ceiling has been removed due to leak; temporary plastic sheeting provided.

There does appear to be an ongoing leak from the roof above. Plasterboard has been removed and temporary plastic sheeting provided. Please see section 5.

A new plasterboard ceiling needs to be provided with associated skimming and decoration.

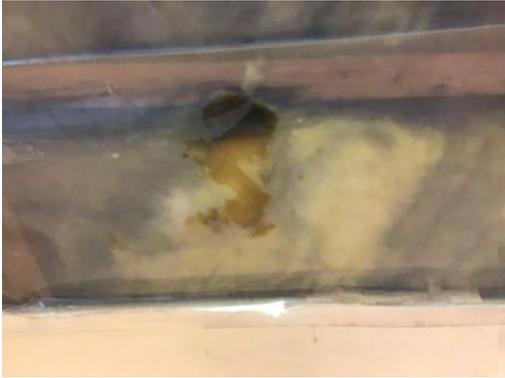
There was noted to be an active leak over the bathroom, there were various other stains to ceilings to the first floor which were not damp, however the tenant has told me that these were past leaks that have been repaired by the landlord.

Water ponding to plastic sheeting to bathroom ceiling.

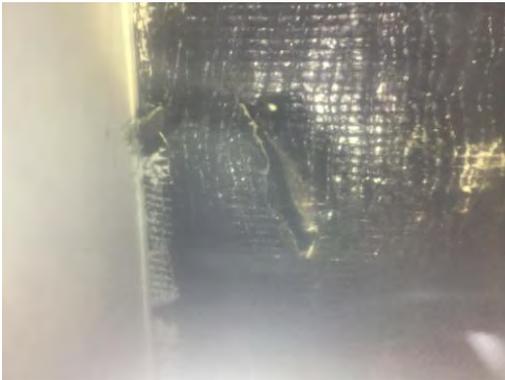
It was noted that some of the tiles above the bathroom appeared to have been lifted and locally re-laid over a modern breathable underlay at some point in the past, however this has not completely solved the problem.

Torn underlay above bathroom

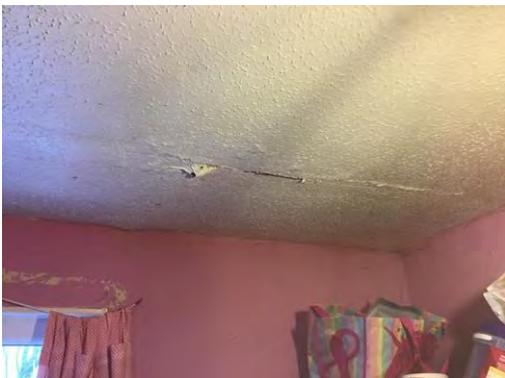
Various past stains to ceilings not damp.

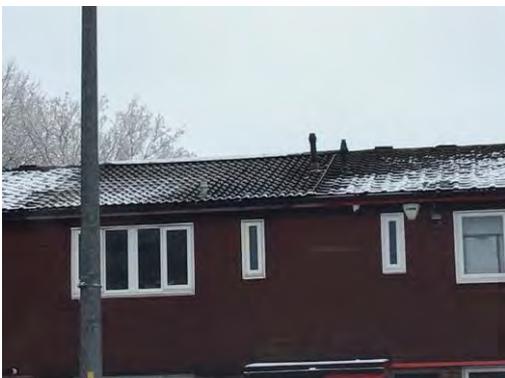
Neighbouring house recovered.

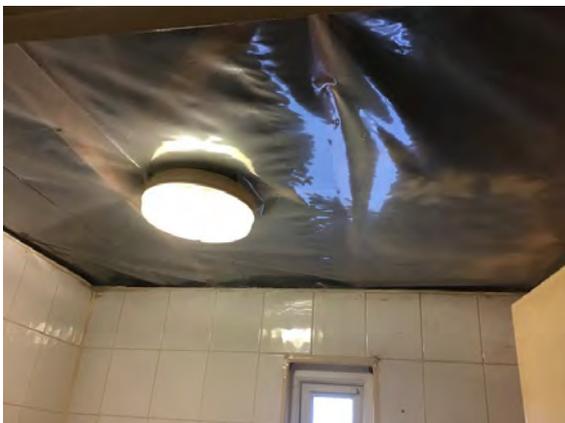
Temporary plastic sheeting used on ceiling

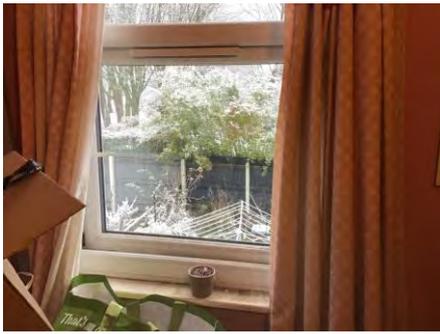
The rear right hand side bedroom window was poorly fitting and as a result could not be secured closed.

Window to rear right hand side bedroom cannot be closed.

Three bedroom windows require adjustment.

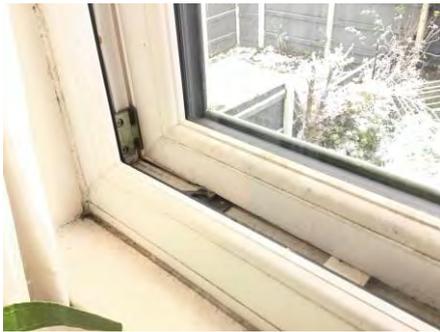
Rear right hand side bedroom window catches at base, preventing closing.

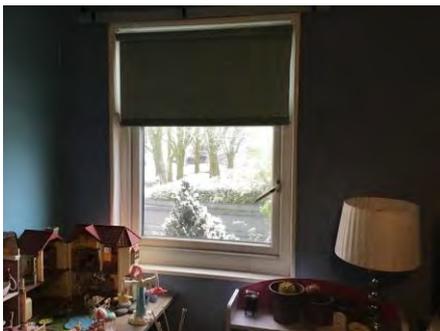
The rear left hand side bedroom window and one of the front bedroom windows were stiff to operate.

Window to rear left hand side bedroom, stiff to operate.

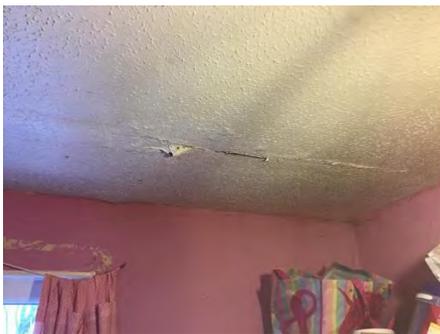
There has obviously been a leak to the rear right hand side bedroom ceiling. There is deteriorated loose plaster board in this room.

Yes, the textured bedroom ceilings could contain some asbestos.

Rear right hand side bedroom ceiling, past water damage, replastering works required.

Part of the ceiling to the rear right hand side bedroom requires replacement and redecoration.

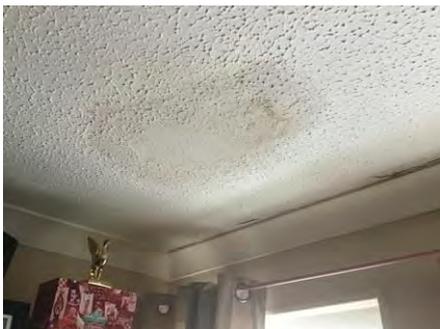
There is more minor past water damage to the ceiling in the rear left hand side bedroom, and front bedroom.

More minor damage to other ceilings, does not necessitate replastering, only redecoration.

Parts of the ceilings to the other two bedrooms just require redecoration.

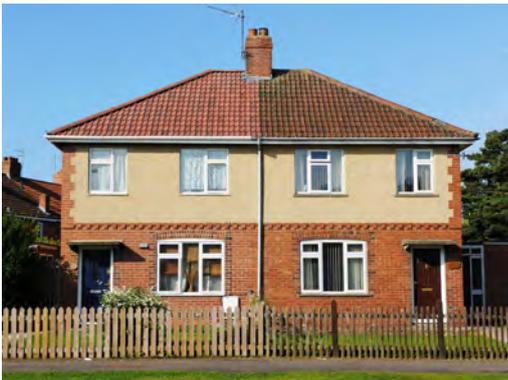
I can confirm that there is no lighting to the front or back of the property.

No external lighting to rear of property.

None, in my opinion this cannot be classified as statutory disrepair.
