# RICS **Building Survey**...

1 Example Street  
Example Town  
Example County  
EX1 8MP

11 October 2019

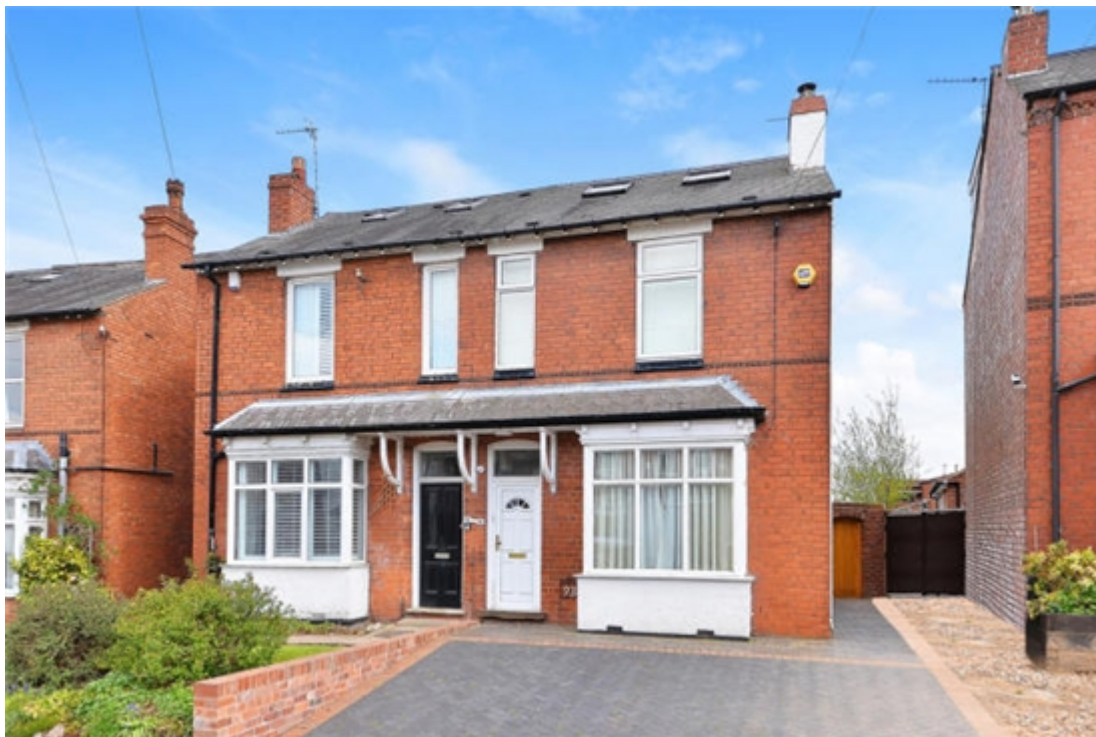
Windows to the first floor have a very limited opening range and this would not give adequate means of escape in the event of a fire.

It was noted that there were no fire alarms within the property.

I recommend that all bedrooms are fitted with windows that could be used as a means of escape. I would also recommend that the property is fitted with a mains powered and battery back up fire alarm system.
