Your survey report

1 Example Street Example Town EXM PLE

Inspection Date 1st September 2021

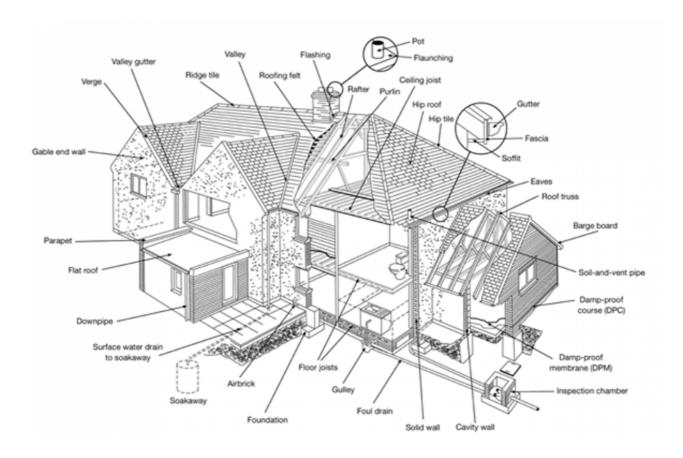
Typical house diagram

This diagram illustrates where you may find some of the building elements referred to in the report.
