LEVEL 2

Your survey and valuation report

1 Test Street Test Town Test City TE1 1ET

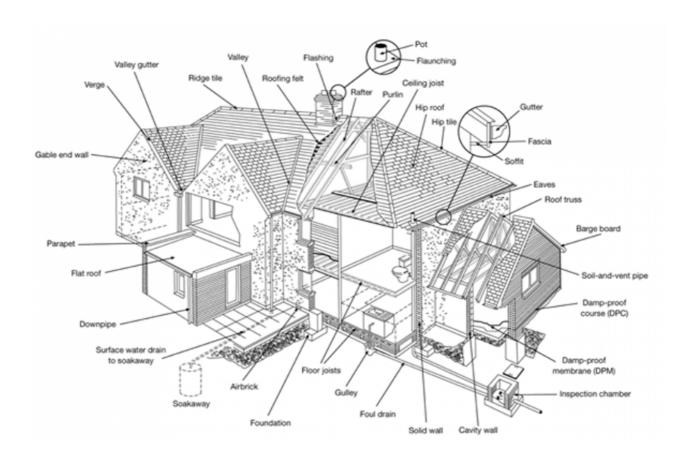
Typical house diagram

This diagram illustrates where you may find some of the building elements referred to in the report.
