LEVEL 3

# Your survey report

1 Example Street Example Town EXM PLE

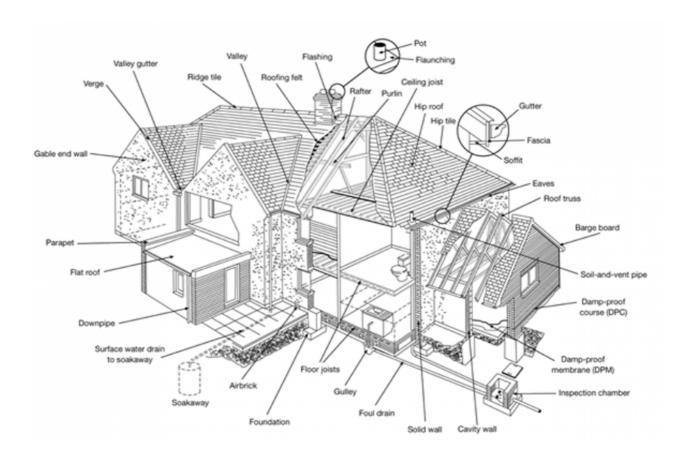
## Typical house diagram

This diagram illustrates where you may find some of the building elements referred to in the report.
